Case Study #2: The URETEK Deep Injection Process on a Public Culvert

- Customer Profile:** The Alabama State Department of Transportation (AL DOT).
- Customer Environment:** A large underground void forms beneath a public culvert under a busy public roadway.
- Customer Situation:** Soils below the culvert were eroded; Water flowed beneath the culvert compromising the structure and roadway above.

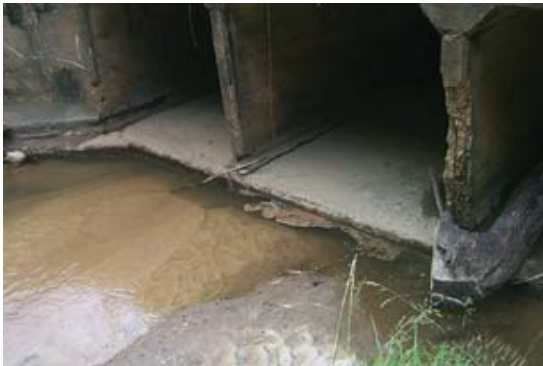
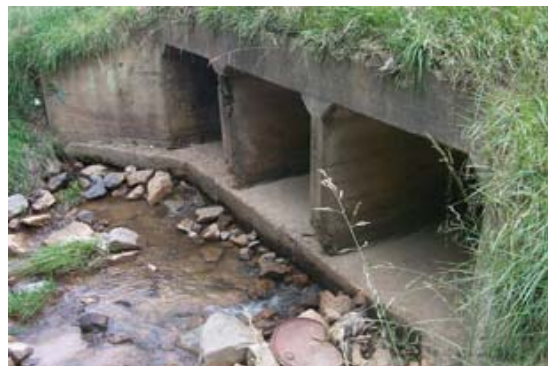
Figure 4 - Water Flowing Underneath a Public Culvert

After many years, the soil beneath a 3 barrel culvert had washed away to the point where the stream water no longer flowed through the culvert but into a large void. Figure 4 below, illustrates this problem showing the entrance and the exit of this culvert, with water flowing beneath the infrastructure.

Culvert Entrance

Culvert Exit

After careful review of possible repair options AL DOT chose URETEK USA to fill the existing voids, and stabilize the existing culvert structure.

Methodology: URETEK applied a uniform injection pattern for the polymer material, ensuring an even disbursement of the material throughout the void area. With the three barrel design of the culvert, URETEK used a multi-point pattern injection spread evenly across each of the three culvert barrels. The two barrels located directly above the deepest section of the void received the most injections, while the third, outer barrel received the remaining injections.

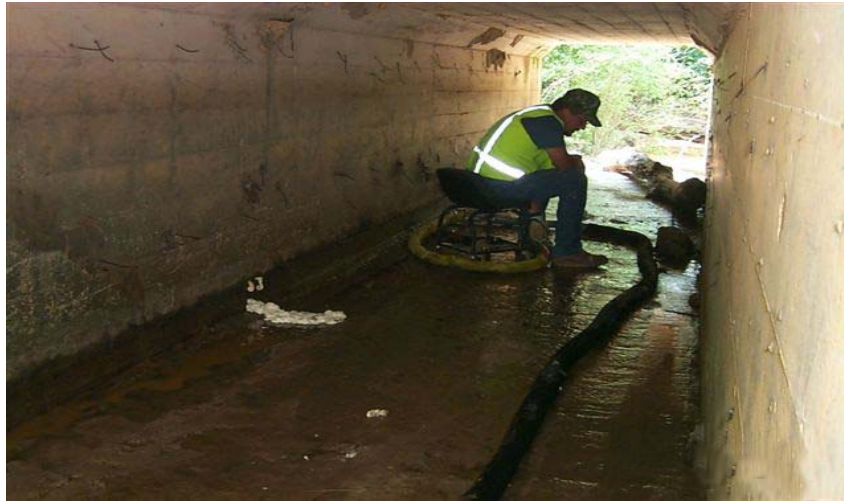
Figure 5 - Injecting Polymer Material into one of the 3-Barrels

Validation: The injection process began at 8am in the morning and was concluded by 3pm that afternoon. Continuous injection of polymer along the base of the culvert gave visual assurance of filling. The rapid curing time of URETEK's material allowed both traffic lanes of traffic above the culvert to be fully opened to traffic by 4pm. URETEK's rapid resolution to the problem saved AL DOT from having to manage several weeks of detours and disruptions, as well as the additional expenses associated with lane and traffic closure.

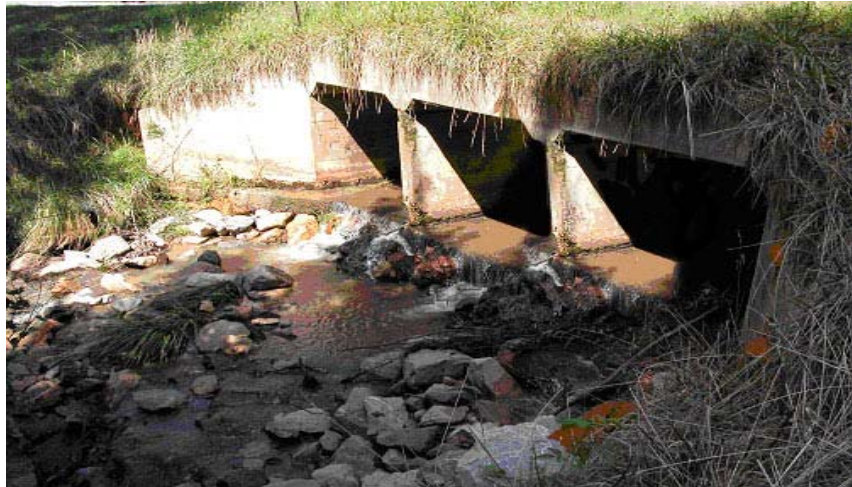
Figure 6 below shows the repaired infrastructure, with water re-directed and correctly exiting through the culvert.

Figure 6 - Water Correctly Exiting Through the Repaired Culvert
